# **Omaha Wastewater Treatment Plant Irrigation Bypass Incident Report**

Final - August 2022

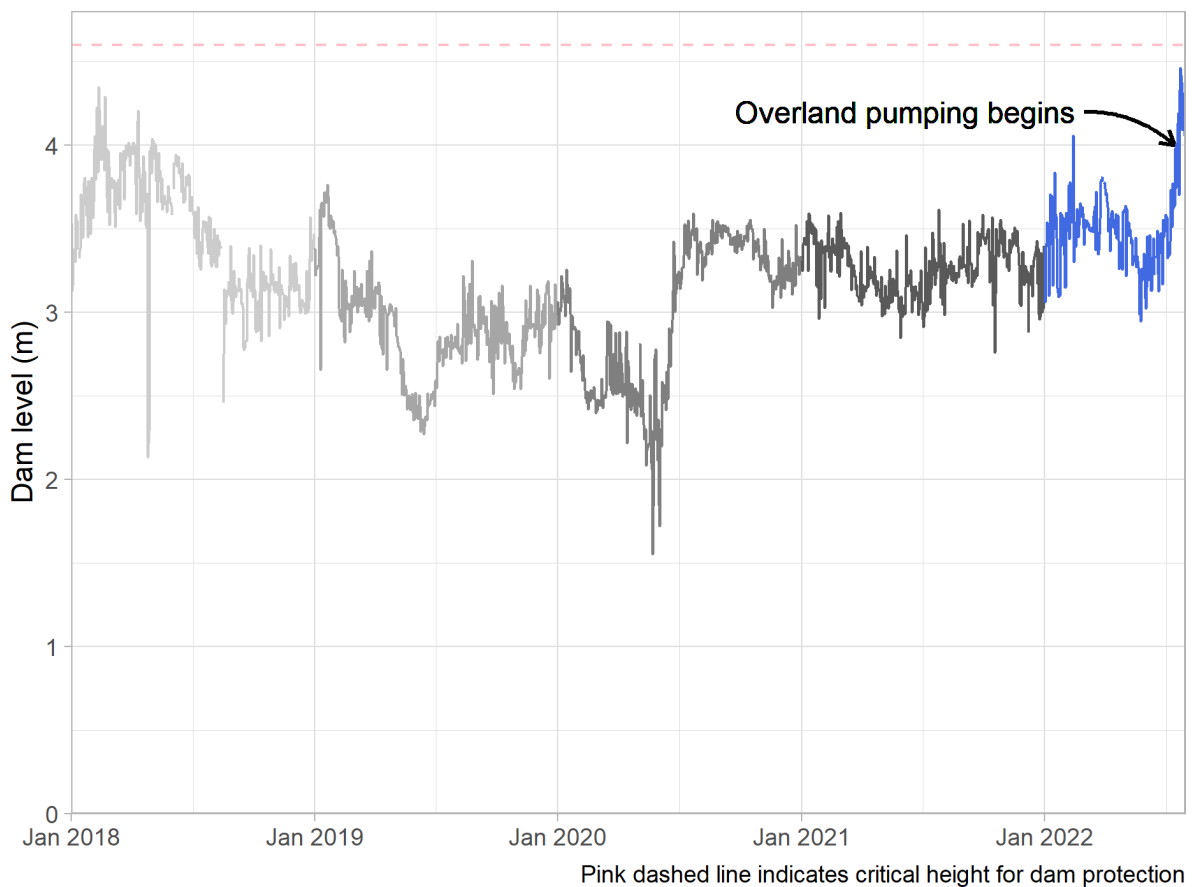
**Figure 4 Average daily height of the Omaha storage dam from January 2018 to July 2022 (inclusive)**

The purpose of the storage dam is to provide a buffer for when the output is less than the input. However, through early July, levels in the dam started to rise on a trajectory that risked dam integrity unless Watercare took preventative actions (Figure 4). High levels significantly increased the risks of dam instability, and potentially an uncontrolled discharge of the stored effluent in the event of overtopping.

To protect the dam, Watercare pumped from the storage dam to stormwater, which was the only practicable option available. The volumes were too high to truck to another site, there were no other storage options, and irrigation rates were already at their practical maximum.

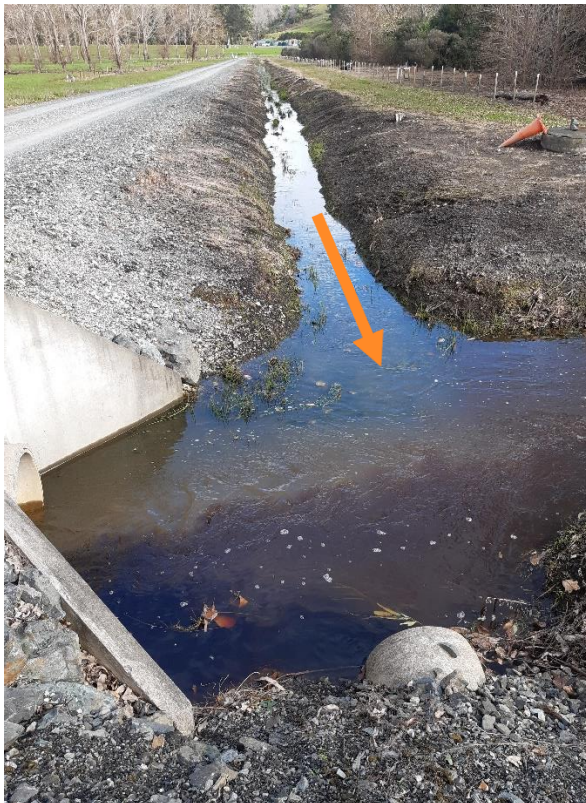
Photos taken on 26 July indicate that the discharge was clear, relative to the receiving stormwater. As Figure 6a shows, the channel that Watercare pumped to was clearer than the water it joined, having reasonable clarity (Figure 6b). The clarity of water at the near-field confluence was poorer again (Figure 6c).

a) Confluence between discharge and near field sampling point (looking southwest)

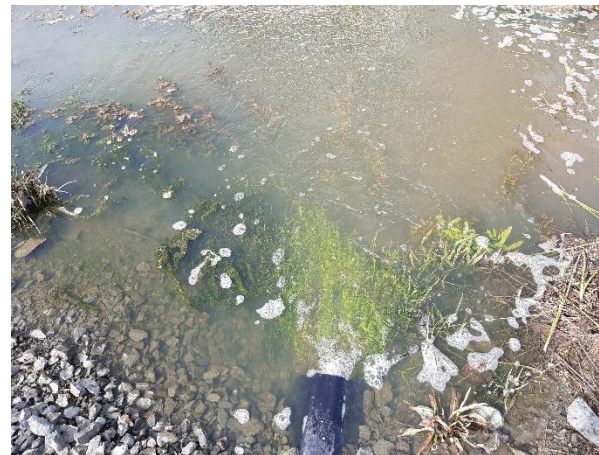
b) Pumped flow to stormwater above confluence

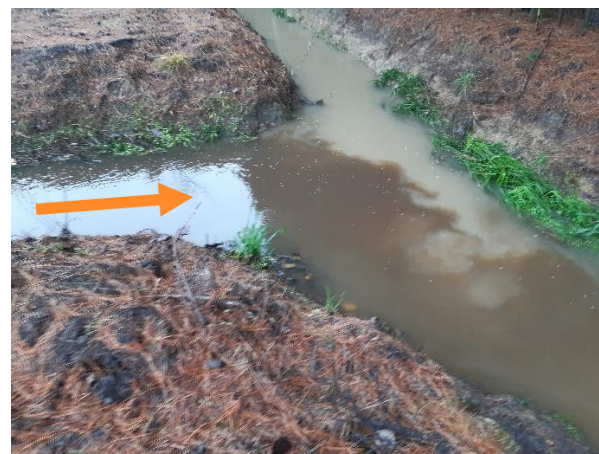
c) Near-field confluence looking southwest

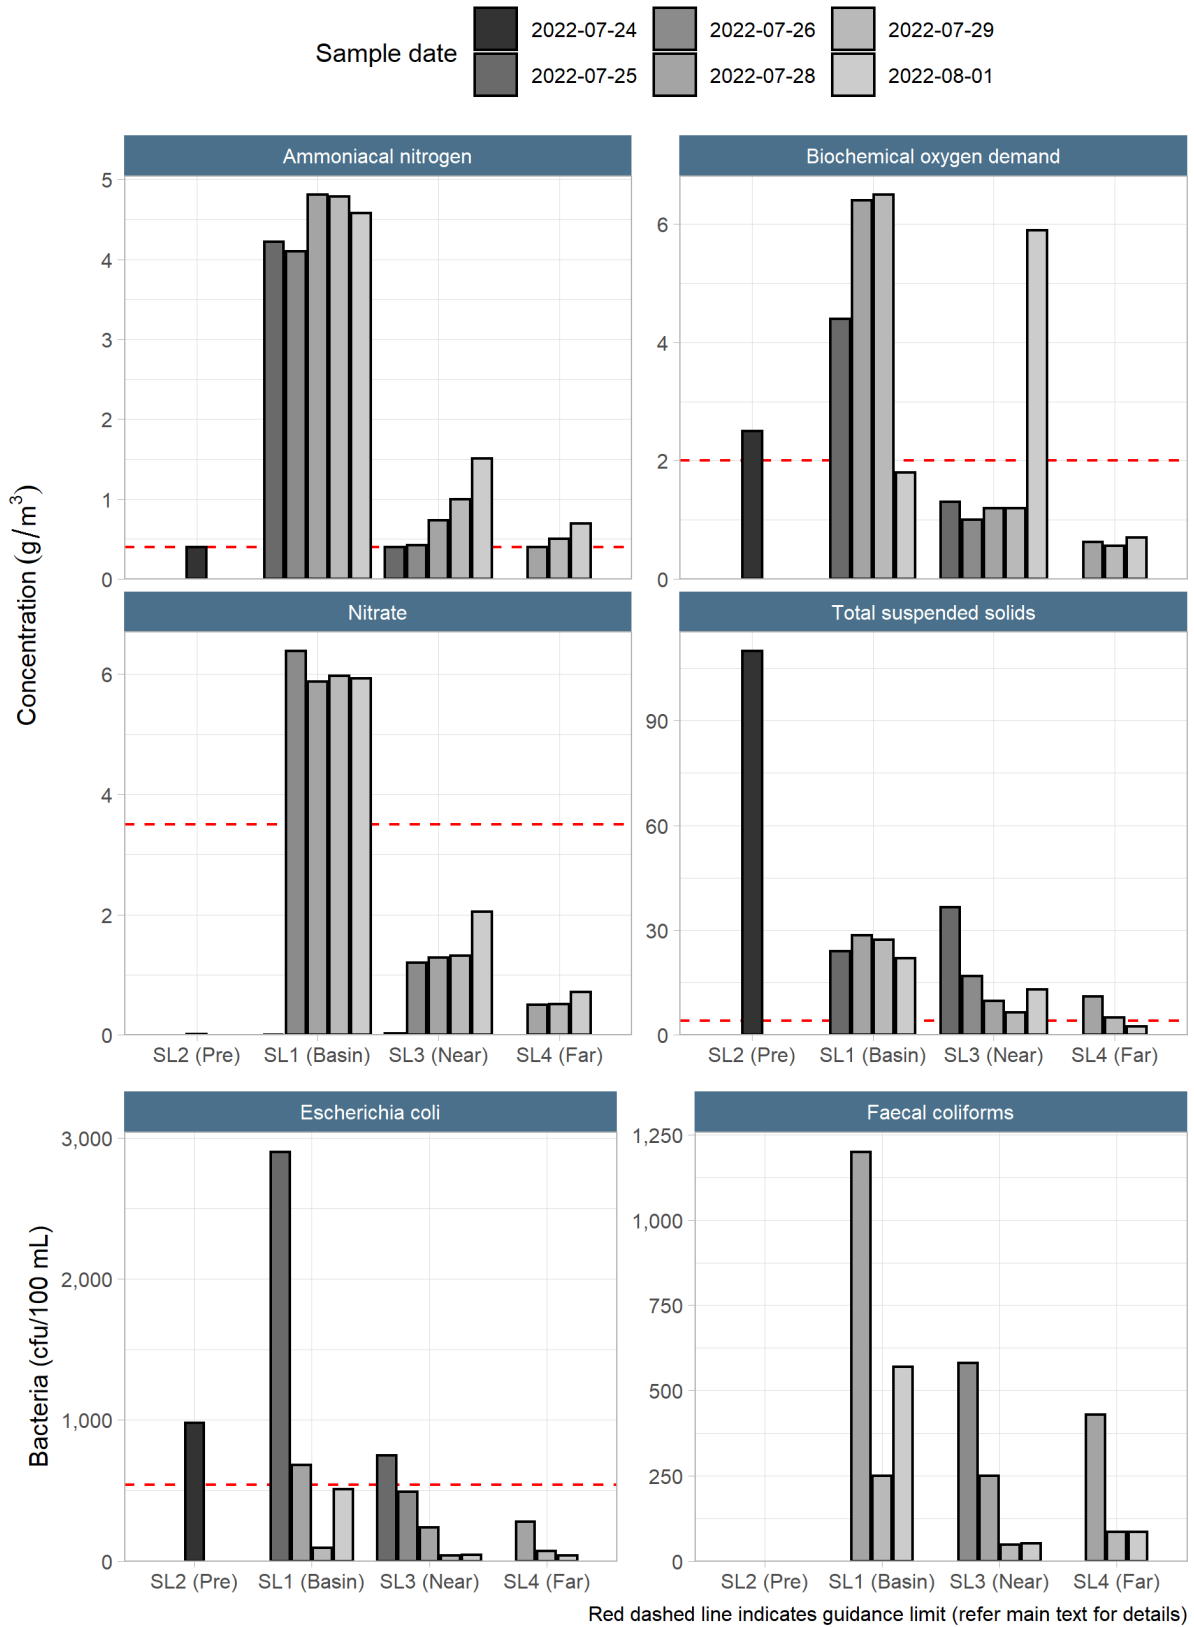
**Figure 7 Receiving environment water quality results during the July 2022 bypass incident**

Figure 7 presents water quality monitoring results through the period of stormwater discharge. These results indicate:

- Biochemical oxygen demand
  - With a single exception, there was sufficient dilution and attenuation of biochemical oxygen demand at the near field site.

- Biochemical oxygen demand concentrations were consistently low at the far-field site.
  - The results for the last sample (1 August) are anomalous. While a laboratory error is possible (e.g., mis-coded results between the dam and downstream), no similar anomalies presented for any other parameter.

- Nitrogen species
  - Concentrations of both ammoniacal nitrogen and nitrate were consistently higher in the dam than in the receiving environment.
  - The increases in both nitrogen species over time are likely a reflection of less dilution as heavy rain events transitioned to lighter showers and run-off volumes decreased.

- Concentrations of ammoniacal nitrogen were above the NPS-FM bottom line for ammoniacal nitrogen, but less than two-fold dilution in the Omaha River would have been necessary to mitigate any effects.

- Nitrate concentrations in the receiving environment were consistently below the NPS-FM 95%ile bottom line.
- Total suspended solids
  - On 25 July, total suspended solids concentrations were lower in the dam than in the immediate receiving environment, but the receiving environment improved over time while concentrations in the dam were consistent.

- Decreasing concentrations over time indicate that run-off was a significant source of suspended solids to the stormwater channels
  - Concentrations of total suspended solids at the far-field site were above the 4 g/m<sup>3</sup> threshold until 1 August but would have further decreased with dilution in the Omaha River (the ultimate receiving environment).

- Bacteria
  - Bacterial counts were high in the dam but decreased with distance.
  - Unlike the results for nitrogen, but like results for total suspended solids, bacterial counts decreased over time in the receiving environment. These declines indicate that run-off was a significant source of bacteria to stormwater and with decreasing run-off, the bacteria load also decreased.

- *Escherichia coli* levels were consistently below the 95%ile for Class A recreational contact waters at the far-field site, and only above this threshold at the near-field site on the first day of pumping (25 July).
