Whangateau Harbour Esplanade Reserve

Asbestos Management Plan 2020

Client: Auckland Council

AECOM New Zealand Limited

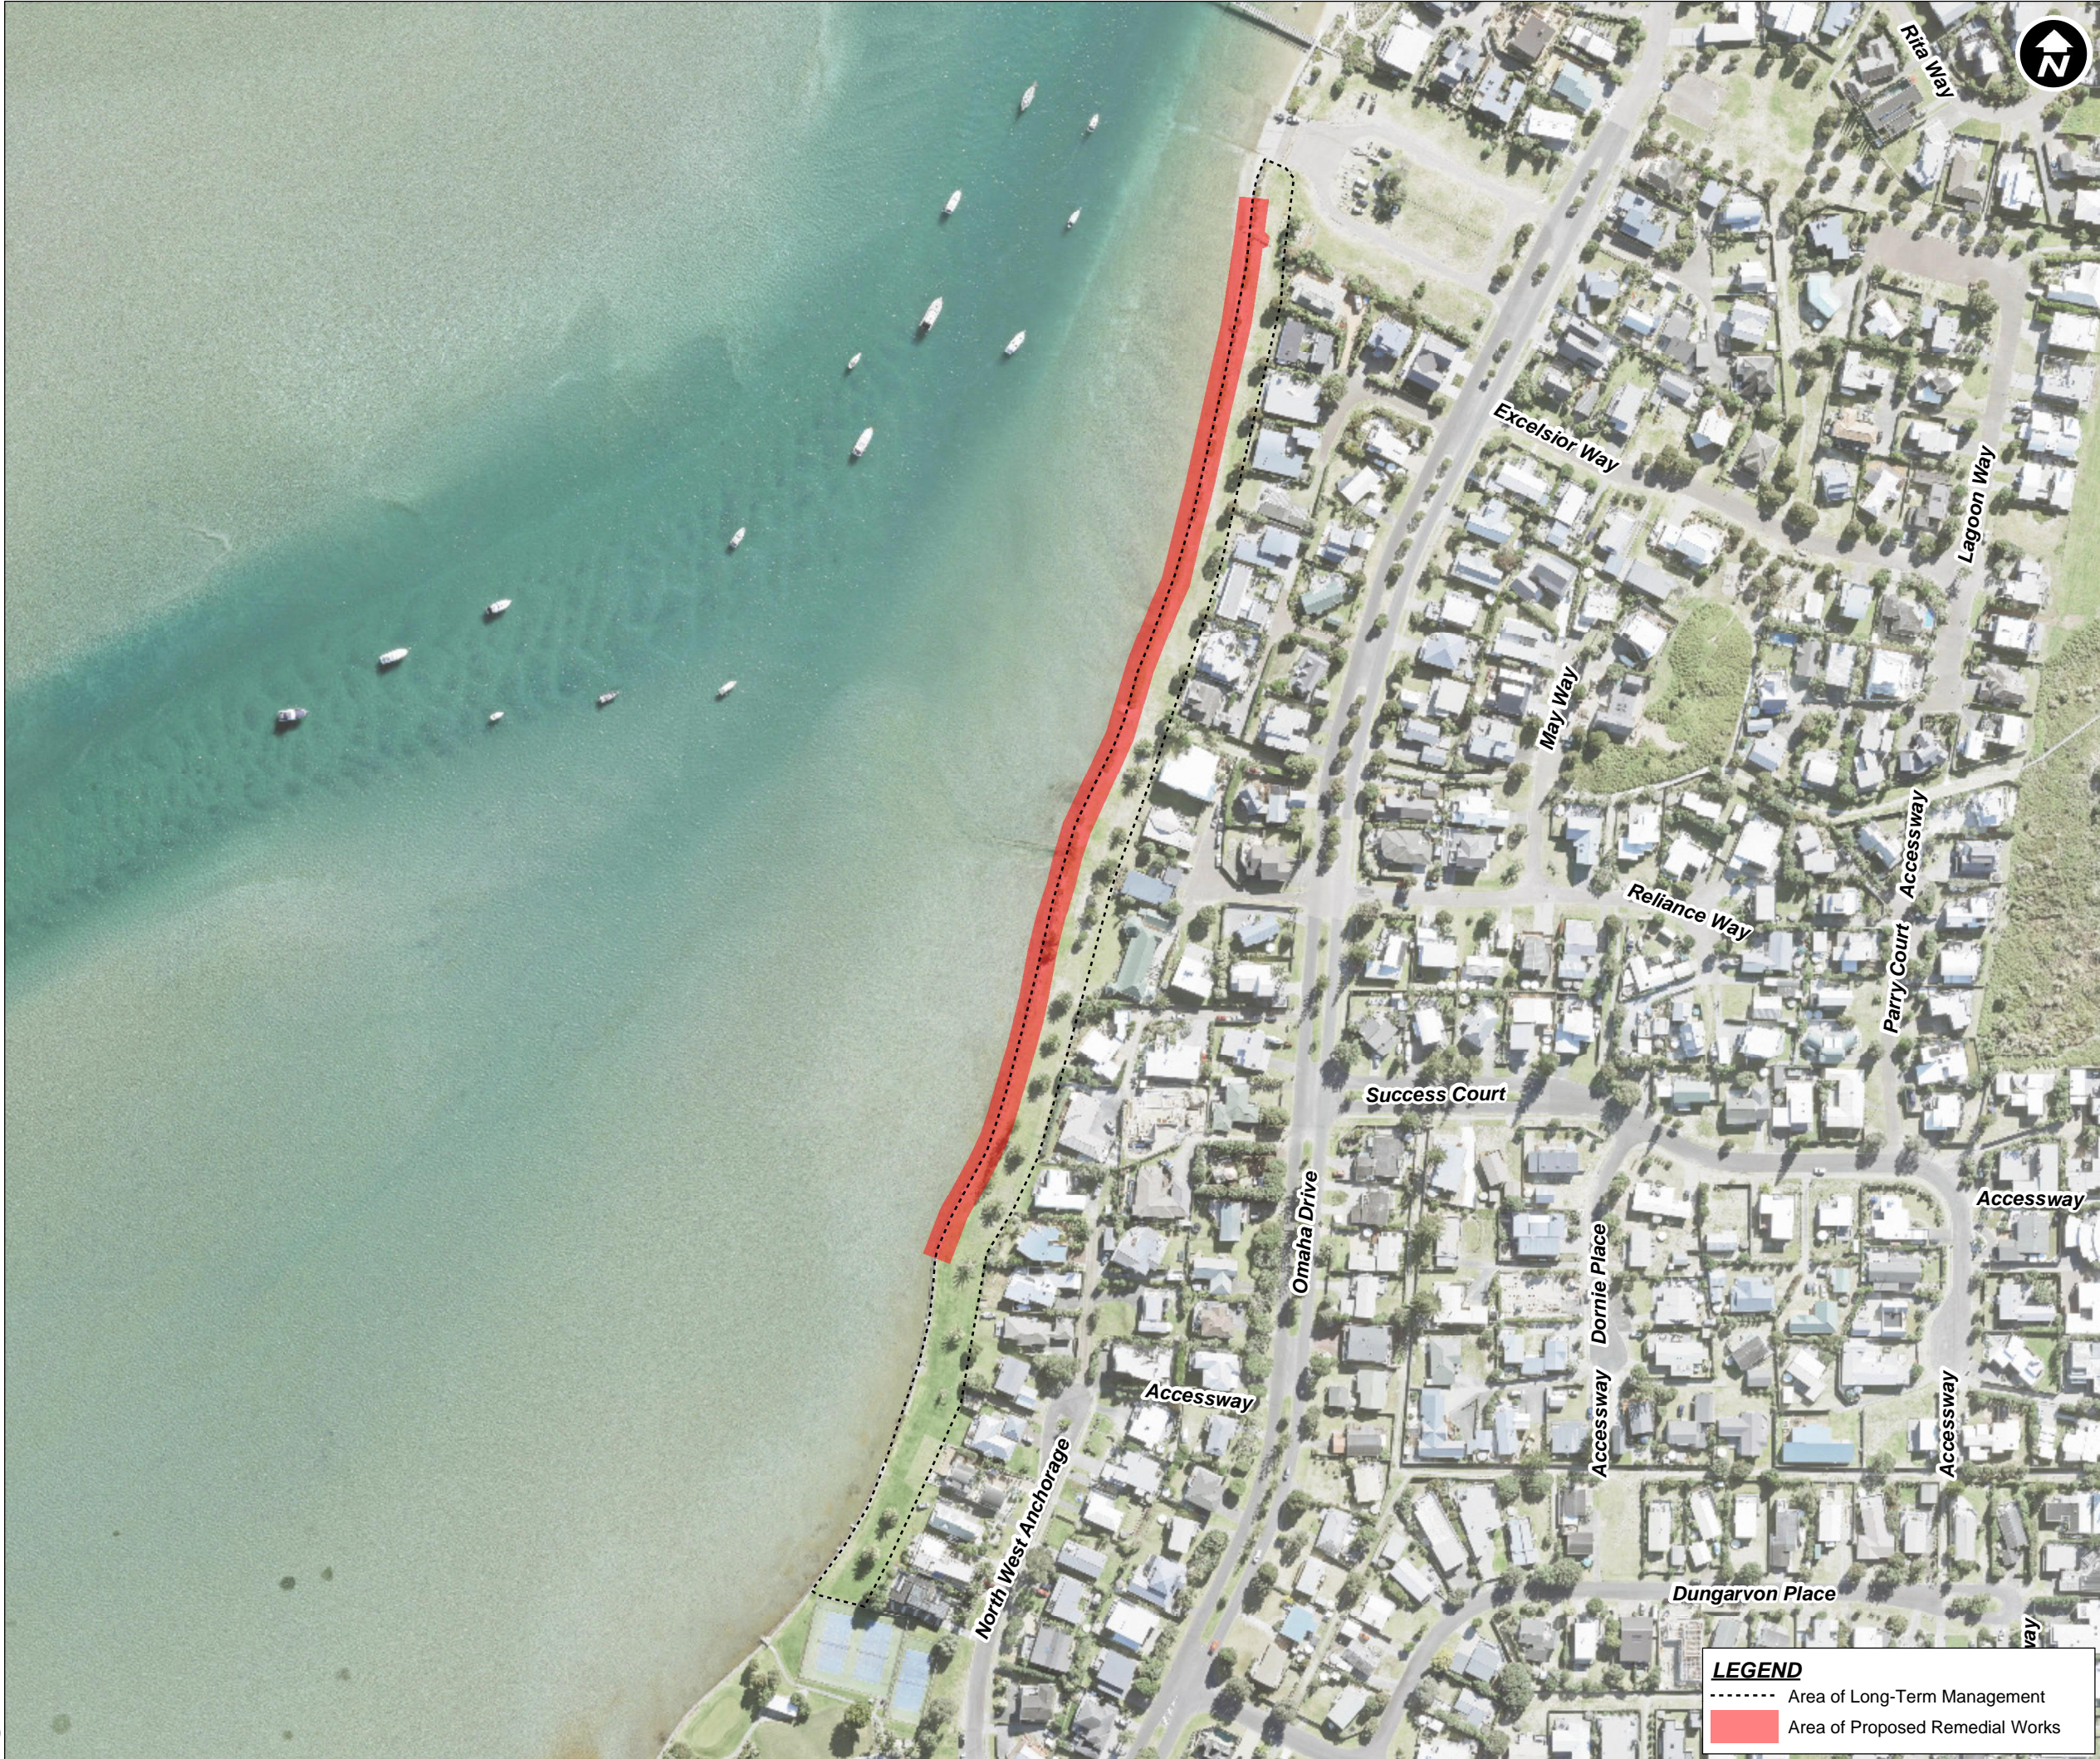
PROJECT NUMBER
60602006
SHEET TITLE
AREA OF LONG-TERM
MANAGEMENT
MAP NUMBER
FIGURE 3

In addition to the areas requiring immediate management, ongoing management is required across the whole Esplanade strip extending from the boat ramp to the tennis club. While asbestos was not identified during the Investigation within the eastern portion of the Esplanade strip adjacent to the residential properties, the spatial distribution of the asbestos exceedances and the discrete nature of the asbestos as a contaminant, it is considered that the whole Esplanade strip ~~may be impacted with asbestos and may present a potential risk to human health.~~ *Refer to changes of this sentence in the Addendum (in **Appendix B** of this AMP)*⁵.

⁶ **Changes reflected in the Addendum:** This *area of proposed remedial works* consists of the western edge of the Esplanade strip, and represents approx. 75% of the total length (north/south) of the Esplanade strip.

Longer-term management of materials and/or areas where asbestos has been presumed present will largely depend on whether any planned future works disturb these materials and/or areas. The area requiring long-term management consideration is presented in **Figure 3** in **Appendix A**, with the *area of proposed remedial works* indicative of where asbestos is more likely to be present. *Refer additional text in the Addendum (in **Appendix B** of this AMP)*⁶.
