# **Omaha Wastewater Treatment Plant Irrigation Bypass Incident Report**

Final - August 2022

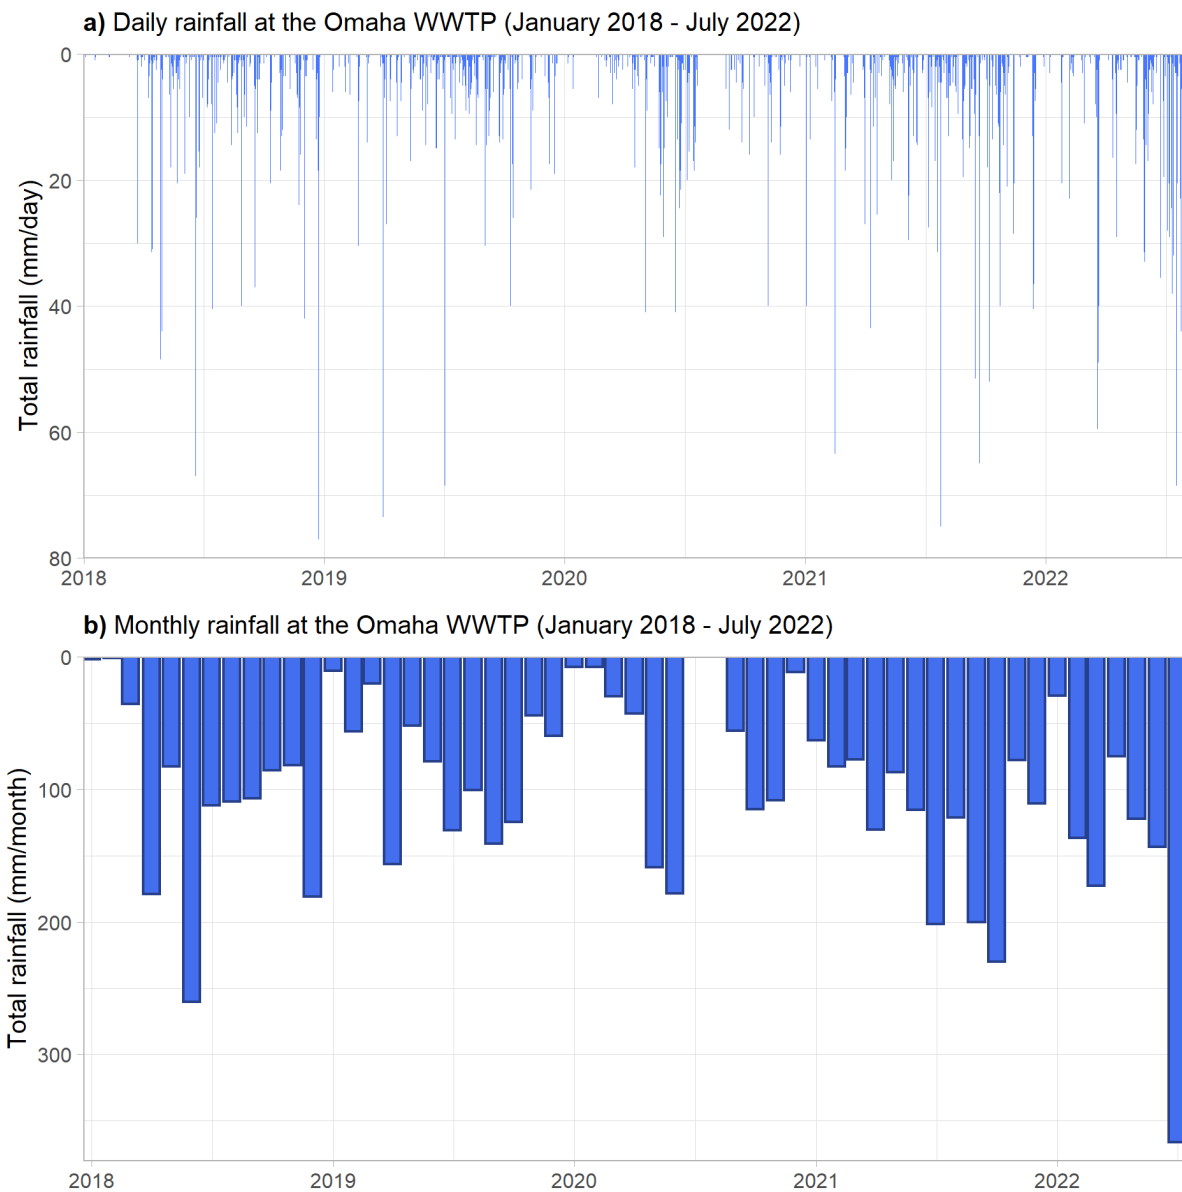
**Figure 2 Rainfall data for Omaha at a) daily and b) monthly resolution**

In July 2022, the Auckland region received twice normal monthly rainfall, with a series of heavy rain events through the middle of the month. While there had been greater individual rain events through the year, in July the rain was heavy and sustained (Figure 2a). As shown in Figure 2b, Omaha received more rain in July than any month in the last five years. Across Auckland, it was the second highest July rainfall on record.

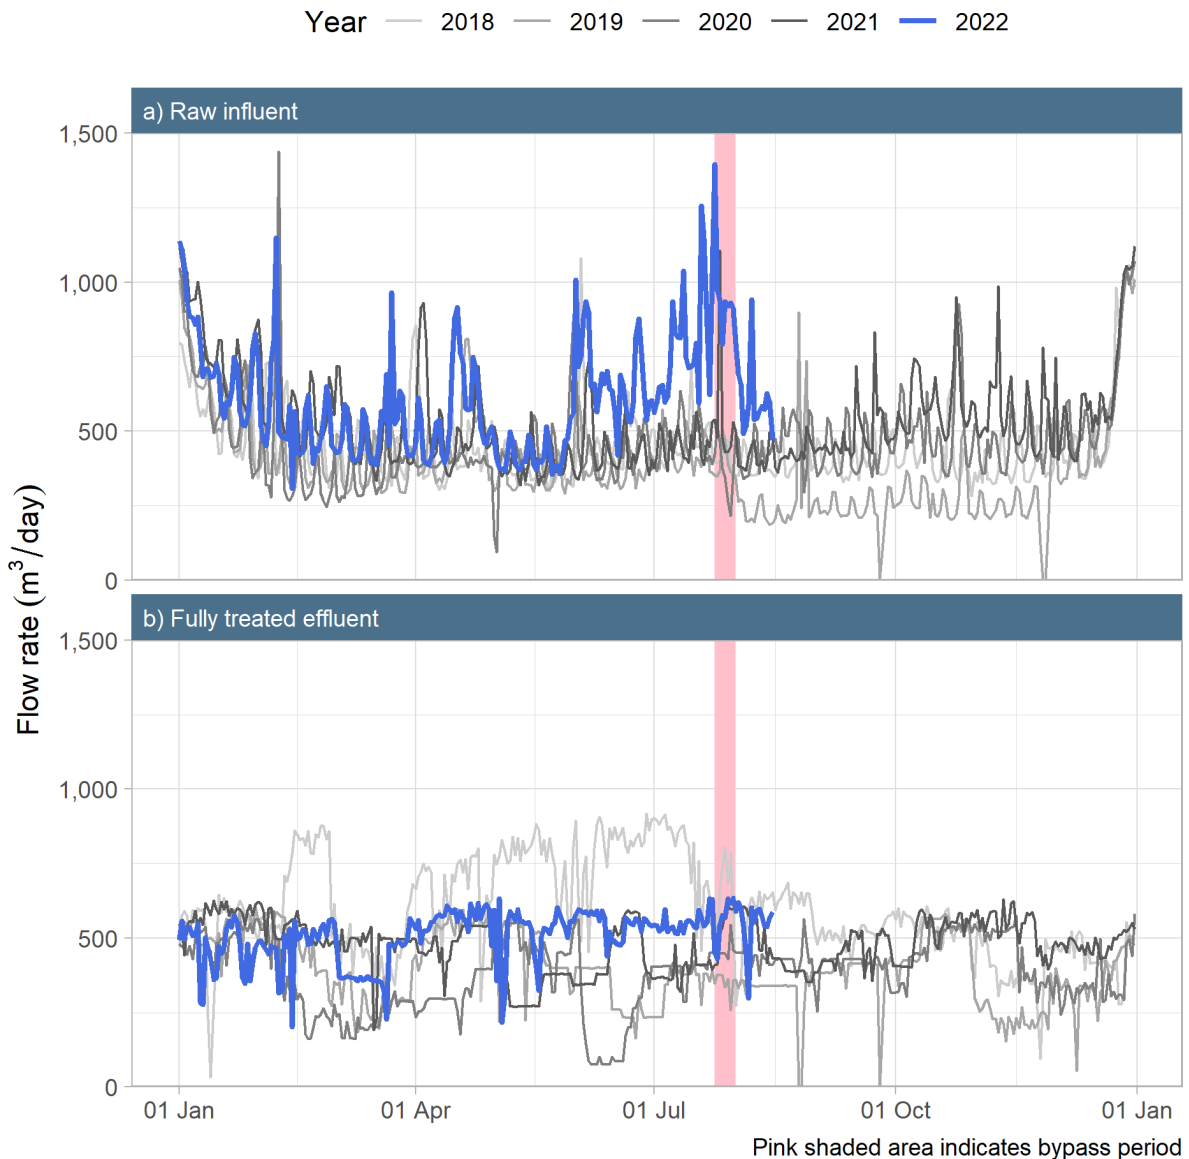
**Figure 3 Flow rates of a) influent and b) effluent through the Omaha WWTP**

The sustained rainfall caused an increase in influent to the treatment plant (Figure 3a). Again, while influent spikes occur year-round, the duration of the spikes are normally over shorter timeframes than observed in July 2022.

The consent permits up to 2,200 m<sup>3</sup> per day to the forestry block and 2,100 m<sup>3</sup>/day to the golf course area, rates higher than the influent volumes of July 2022. However, the actual throughput of the system is lower than the consent permits, and discharge rates are lower again when soils are at or near saturation, as occurred in July and August 2022. Particularly since mid-2018, flows out of the treatment plant have typically been 500-600 m<sup>3</sup>/day, much less than comes into the treatment plant during wet weather (Figure 3b).

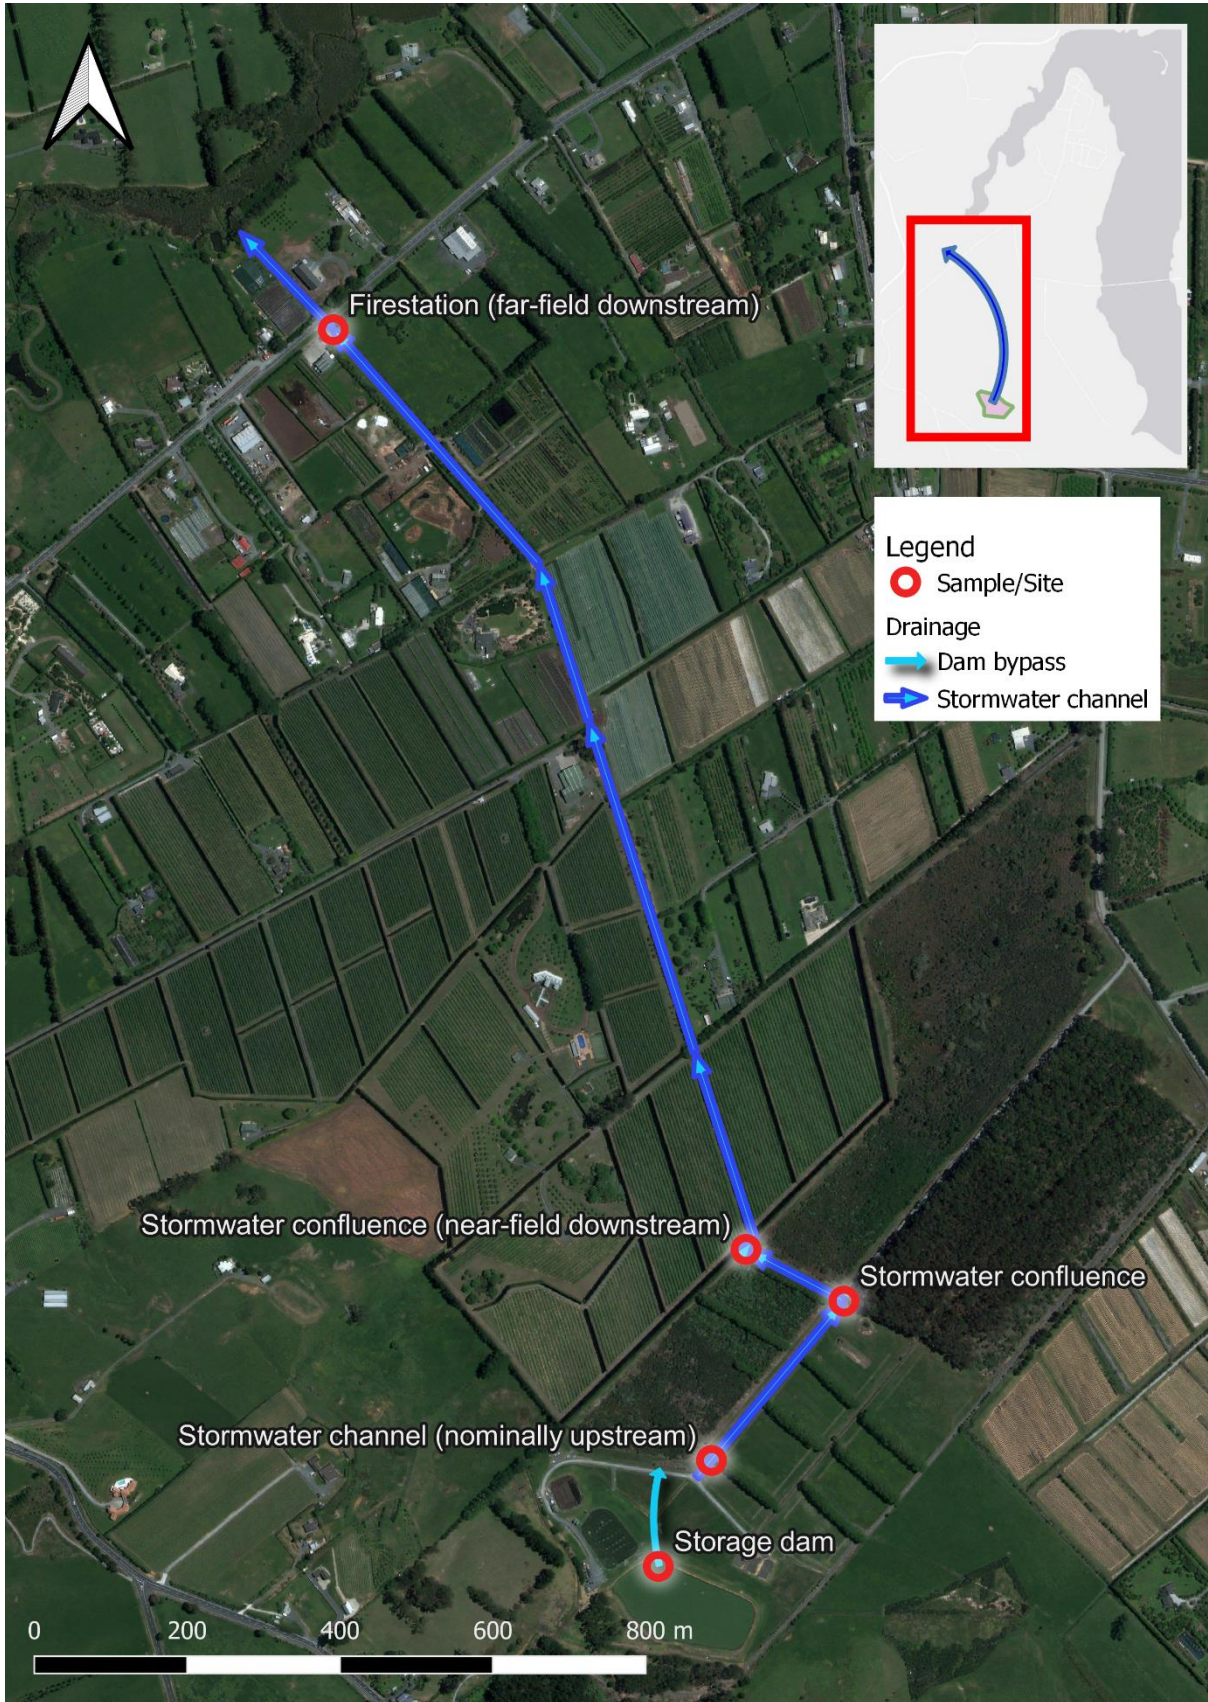
Figure 5 Secondary discharge location, stormwater path and sampling locations

Figure 5 shows the discharge location and stormwater path. The ultimate receiving environment was the Omaha River, north of the treatment plant. Discharges did not go direct to the inner Whangateau Harbour nor to Omaha Beach.

Watercare also took a baseline sample near the point of discharge prior to pumping start on 24 July 2022. Figure 5 shows the sampling locations.
